PRESERVATION STRATEGY OF IRRIGATION PONDS IN URBAN DISTRICT : HISTORICAL DEVELOPMENT, PRESENT STATUS, AND FUTURE PERSPECTIVES

Abstract: Hyogo prefecture prides itself for having the most Irrigation Ponds. The Higashi Harima region was selected as one of the 180 cultural sceneries for its vast collection of Irrigation Ponds. However, as a result of urbanization and ageing farmers, appropriate management of Irrigation Ponds has become difficult, thus causing advancing dilapidation. Also, the inflow of household effluents causes eutrophication leading to the forming of a microorganism known as ‘waterbloom’ that emits foul odor. The introduction of invasive species is also one of the causes of environmental problems in many Irrigation Ponds. On the other hand, these Irrigation Ponds play the vital role of biotope habitats for endangered species and also as recreation parks in the city

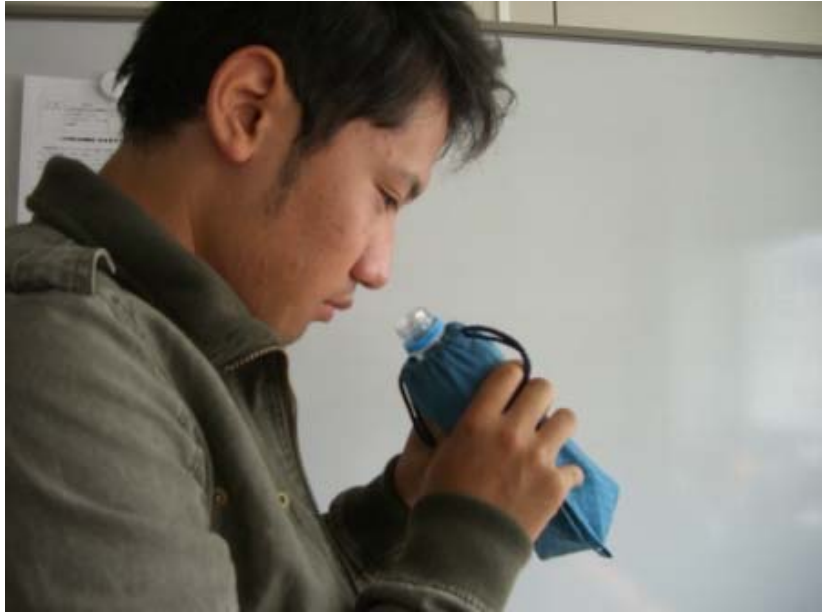
The sample water collected from the irrigation pond is diluted with soft drinking water 1/2, 1/4, 1/8 and so on. The sample water is put into PET bottles. To prevent the panel from judging from the sample's color etc, a covered sample, as well as a blank sample is given to the panel as shown in Photo.1. Next, the panel would open the lid of the PET bottle and compress it before smelling the odor filled inside and choosing the bottle with odor. When the odor becomes thin to an undeterminable level, it is considered as inaccurate. When samples of the same concentration become inaccurate twice, the experiment ends.

Photo 1 How to smell odor

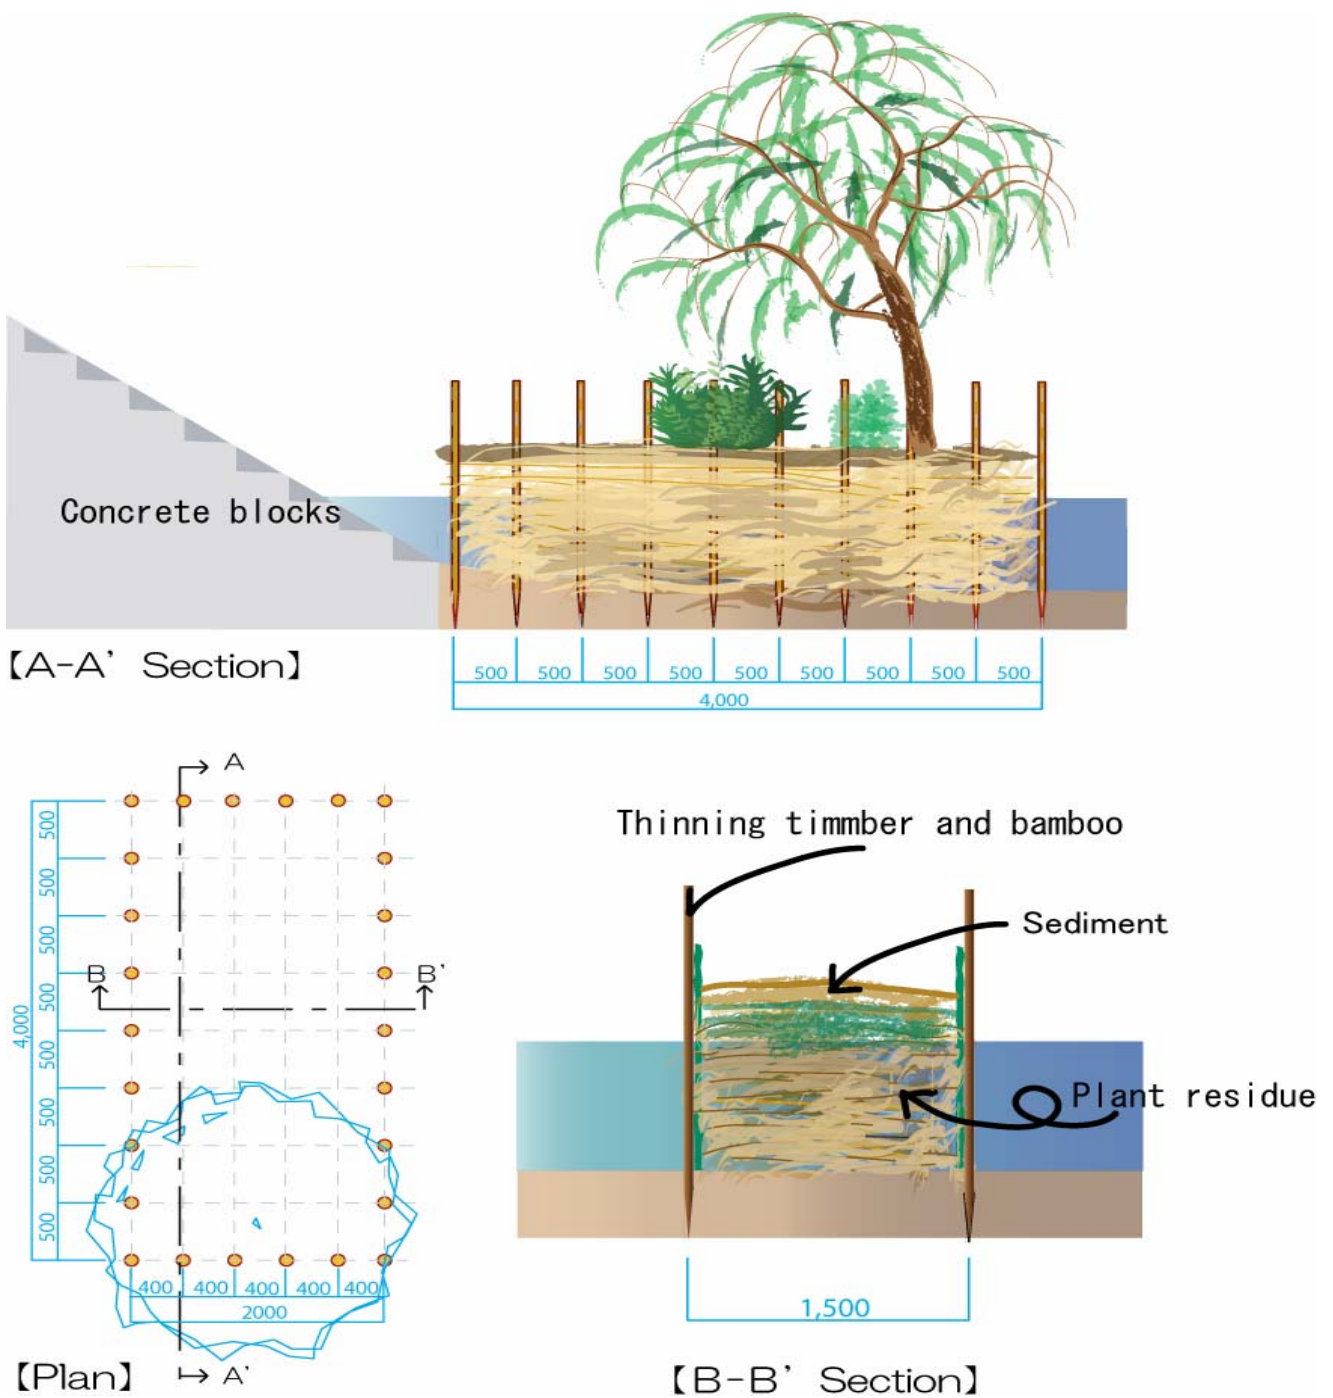
The authors made a Chinampa^{*2} as trial, as seen in Fig.3 using sediment and plant residue to create a structure of biological diversity for water purification and as a habitat for living things. The materials are thinning timber from neighboring area, and bamboos which helped the maintenance of *Satoyama*^{*3}. Although currently surrounded by concrete blocks which make vegetation growth difficult, a water edge structure with more diversity could be made, and nutrient salt could be absorbed with the increase of plants. At the same time, dredged sediment and plant residue are inserted into the Chinampa thus completing the whole role of dredging.

Fig3 Outline of Chinampa in Eigashima Dish Pond
